**NEW MEXICO
ENVIRONMENT DEPARTMENT**

Re: **Wines of San Juan; SIC 2084; NPDES Compliance Evaluation Inspection; NPDES #
NМУ001964; April 4, 2018**

NPDES Compliance Inspection Report

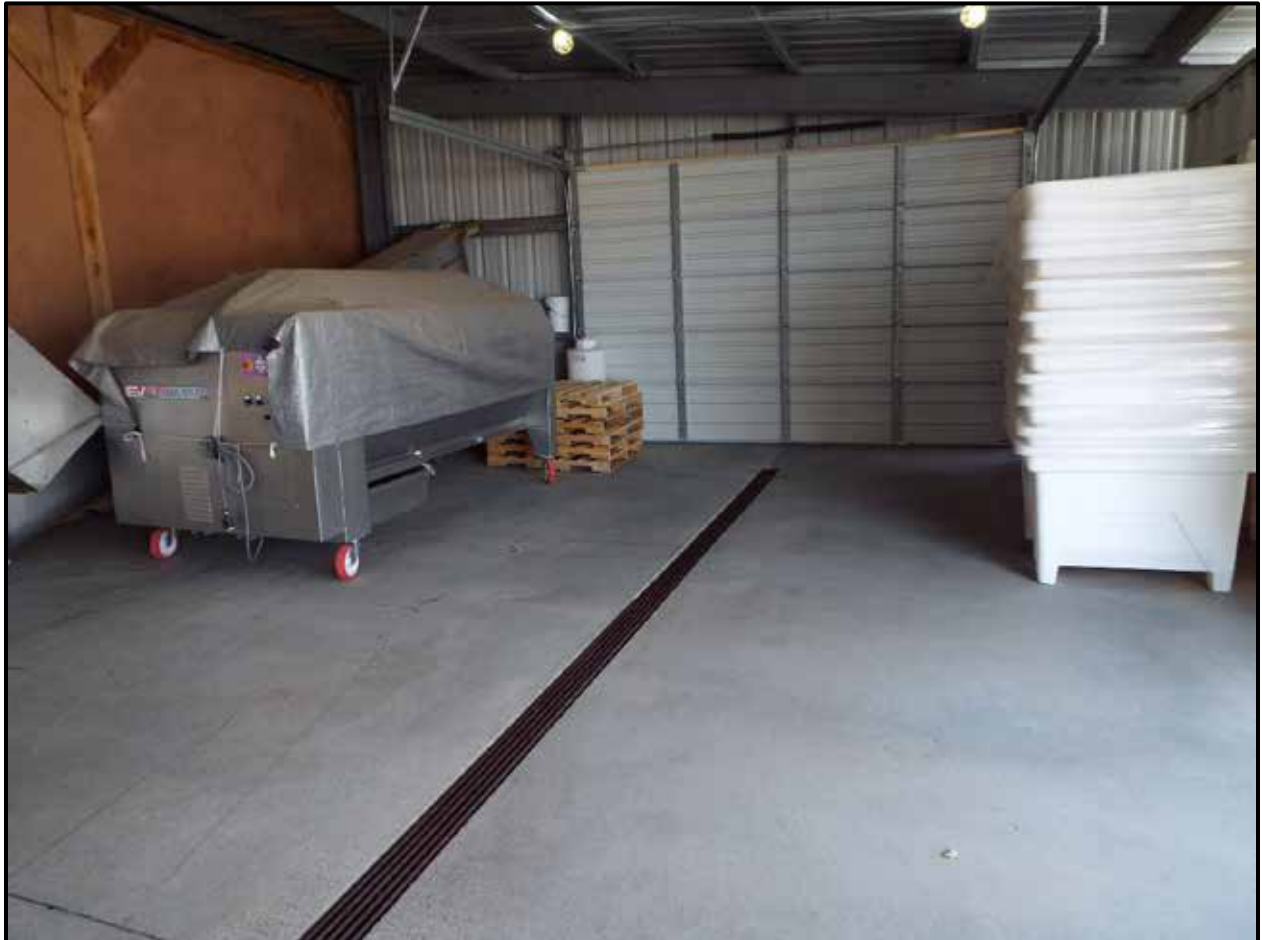
Photo # 1

Photographer: Daniel Valenta	Date: 4/4/2018	Time: 1137 hours
City/County: Blanco/San Juan		
Location: 233 Highway 511 @Turley, Blanco, New Mexico 87412		
Subject: Grape processing area, note floor drains. The floor drains are piped to the San Juan.

I will be installing an above ground storage tank on a cement pad to impound the discharge from the floor drains that collect all the discharge from the winery and crush pad area. The contents of this tank will be hauled to the Farmington waste water facility on an as needed basis.

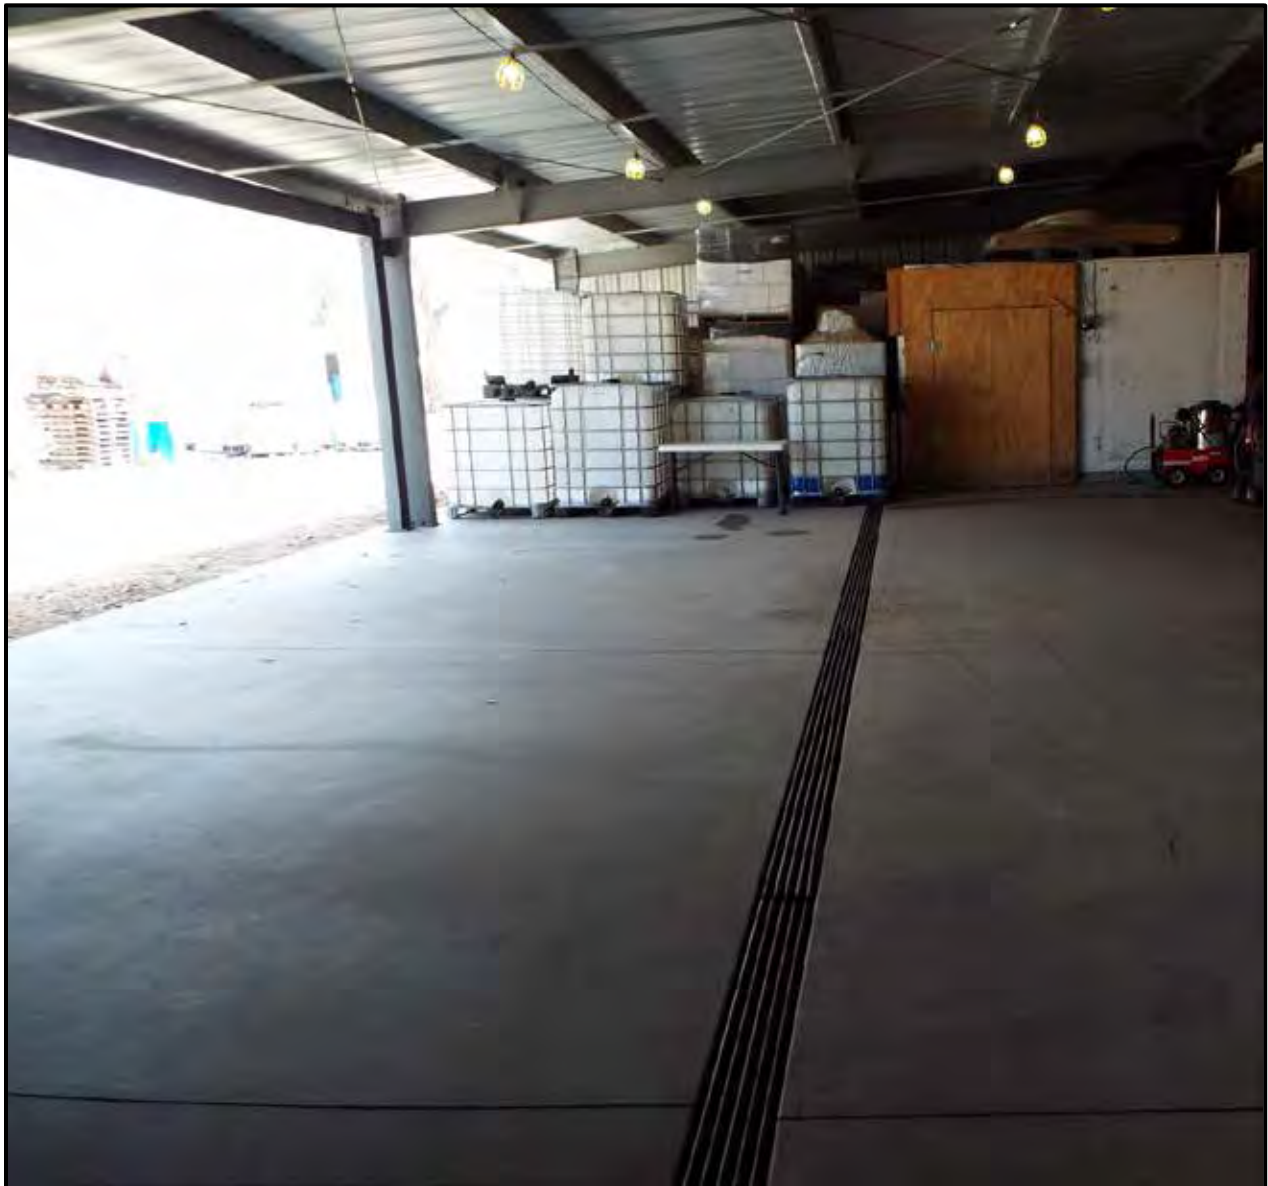
Photo # 2

Photographer: Daniel Valenta	Date: 4/4/2018	Time: 1138 hours
City/County: Blanco/San Juan		
Location: 233 Highway 511 @Turley, Blanco, New Mexico 87412		
Subject: Grape processing area, note floor drains. The floor drains are piped to the San Juan.

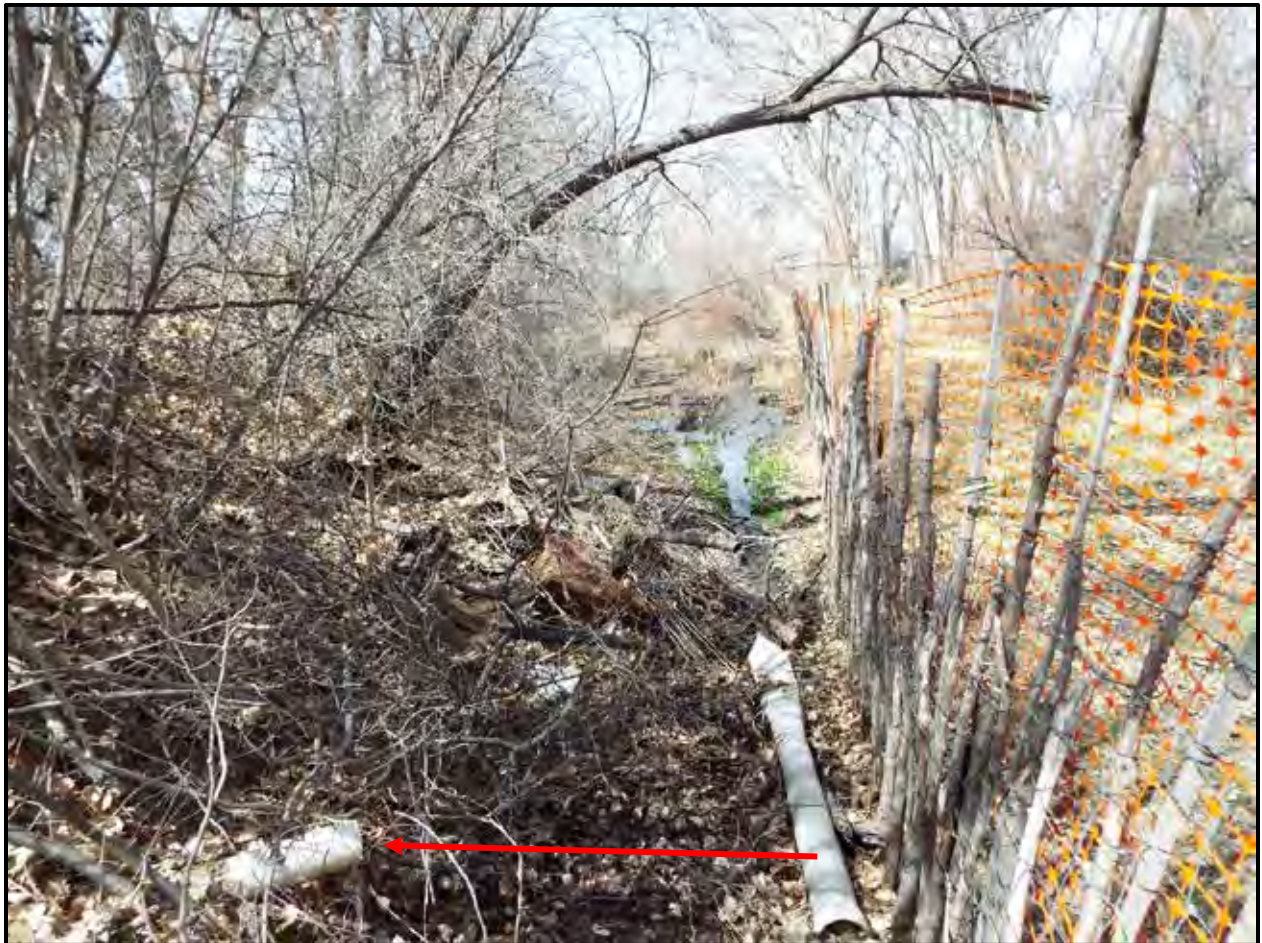
Photo # 3

As of the time of the inspection, the facility did not have either an active or expired NPDES permit in place for the discharges into the San Juan river. More information and how to apply for a NPDES permit can be found at <https://www.epa.gov/npdes>. According to the facility representative the pipe has been in place for around a year. Per Mr. Arnold the discharges depend upon the activities that occur at the winery. Peak volumes of discharge occur during harvest and grape crushing time. Harvest usually starts the first week of August and continues until about mid-October. The pipe discharges to a segment of the San Juan that is dry when the river is low and flows when the river is high. Flow in the river is controlled by releases from Navajo lake. Wines of the San Juan is a small family run operation that produces 3 to 4 thousand cases of wine annually.

Photographer: Daniel Valenta	Date: 4/4/2018	Time: 1114 hours
City/County: Blanco/San Juan		
Location: 233 Highway 511 @Turley, Blanco, New Mexico 87412		
Subject: The floor drains are piped to this side channel which flows to the San Juan. This side channel flows when the river is high. The red arrow is pointing to the discharge pipe.

Hopefully, the containment tank will be in place within the next couple of weeks, and all possible containment from Wines of the San Juan into surface or groundwater will be eliminated.
